STEM TRUNNION TAPER JUNCTION WEAR WITH FEMORAL HEAD OF A TOTAL MODULAR PROSTHESIS

CONSTANTIN ȚIGĂNEȘTEANU, LIVIU FLORIN ISVORANU, ȘTEFAN ALEXANDRU ILAȘ

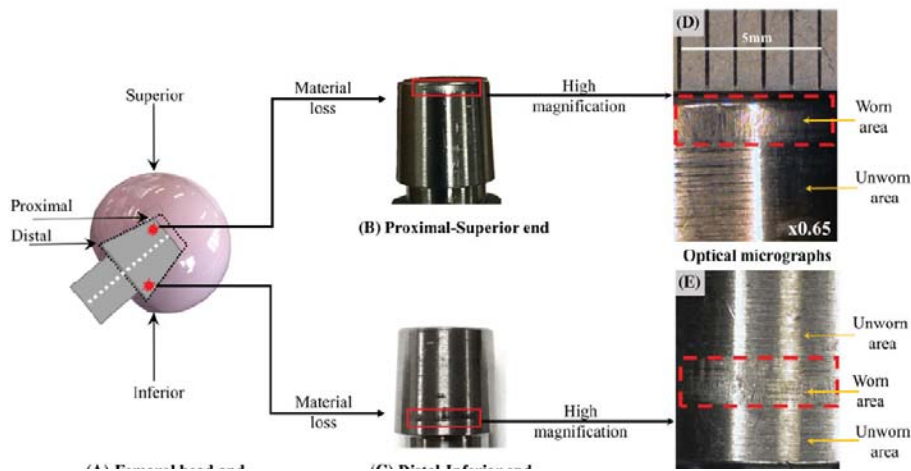
Fig. 2 – A) a femoral head and femoral assembly showing the different anatomical planes; B, C) a test trunion indicating wear at the proximal-superior end and at the distal-inferior end, respectively; D, E) optical microscopic images captured at a 0.65 x magnification showing worn and unworn areas of the superior-proximal end and the distal-inferior ends [19], respectively.

The head and trunnion assembly are shown in Fig. 2 A. On the trunnions, the loss of material (as indicated by the reduction of the mass and the decrease of the roughness) was seen opposite the superior - proximal end and the distal-inferior end, respectively, as shown in Fig. 2 B, C.

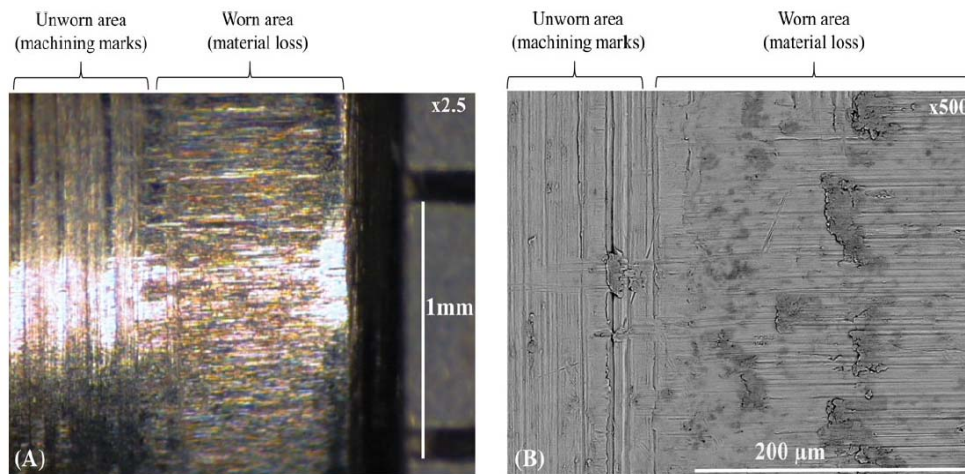
Unworn and worn out areas are clearly visible, and the original circular machining marks are evident in unworn areas. The proximal – superior end of a test trunnion can be seen in Fig. 3 A at a magnification of $2.5 \times$, using an optical microscope and at a magnification of $500 \times$ with an SEM of Fig. 3 B. Again, in the SEM image, two distinct areas, a worn area and an unworn area with original processing marks are displayed.

Fig. 3 – A) An optical microscopic image at $2.5 \times$ magnification;
 B) the microscopic scanning electronics (SEM) image of the $500 \times$ magnification
 of test trunnion, showing worn and unworn areas [19].

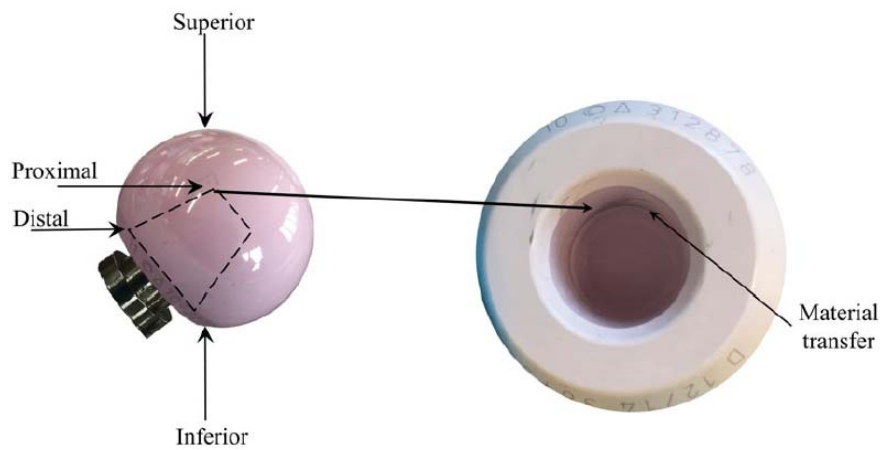
Figure 4 shows the femoral head and a trunion-head assembly, showing the various anatomical planes and internal taper of a tested femoral head showing a gray ring [19].

Fig. 4 – A) The femoral head and a trunnion-head assembly, showing the various anatomical planes; B) internal taper of a tested femoral head showing a gray ring [19].

Femoral head tapers showed a statistically insignificant change ($p > 0.05$), such as the 2D (S_a) post-test surface roughness, indicating a minimal loss of femoral head material in the form of a gray ring visible at the proximal end of the femoral taper, which probably indicates the adhesive wear transferred from the titanium trunion to the taper of the ceramics. This is consistent with an explant study, which noted the transfer of metallic material to the taper surface of the CoC and CoP recovery ceramics. The same study, however, did not report any corrosion by fretting or loss of ceramic material, again this being consistent with our experimental results.

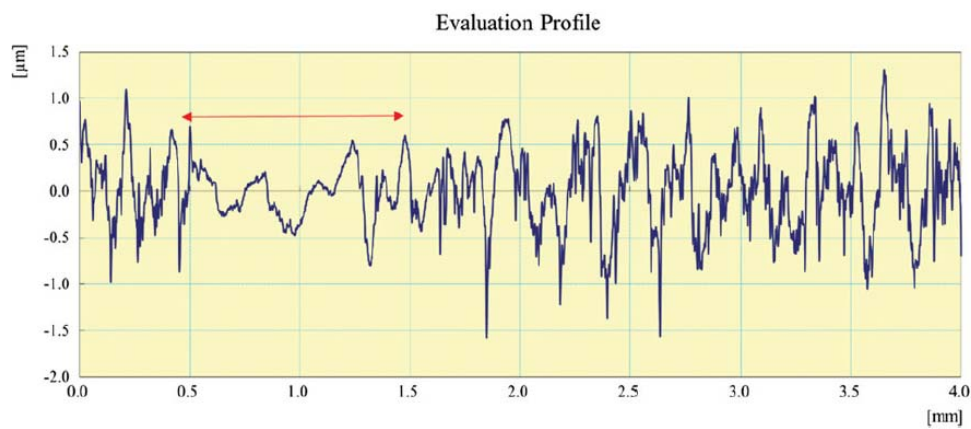
Figure 5 shows an evaluation of the trace profile of a trace obtained on the distal-inferior end of a test area, which shows the worn area.

Fig. 5 – An evaluation profile obtained at the distal - inferior end of a test trunnion ($S_a = 0.321 \mu\text{m}$). The red arrow marks the worn area.

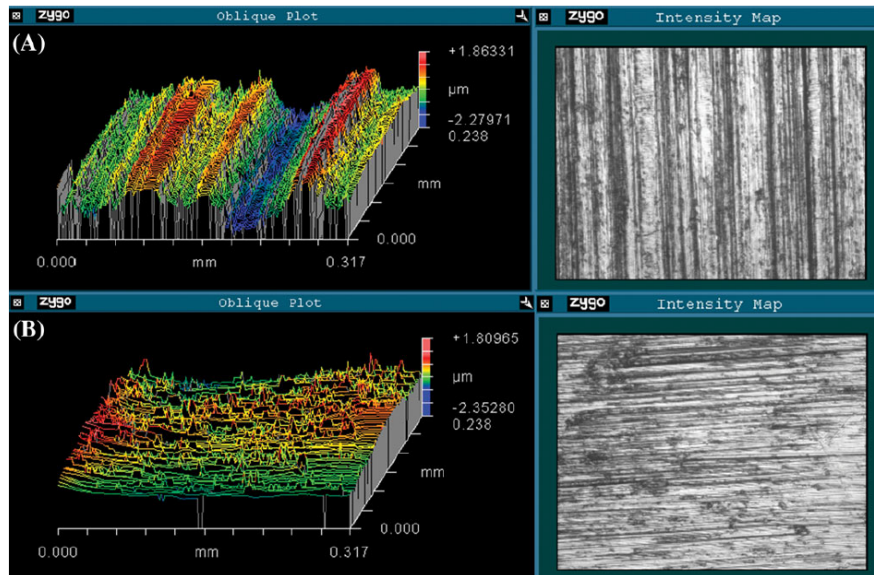
Figure 6 A, B shows profile images acquired with the non-contact profilometer on (A) unworn and (B) worn areas from the superior-proximal end of a tested trunnion.

Fig. 6 – Images of surface topography of a titanium trunnion (A) surface with no visible machining marks ($S_a = 0.565 \mu\text{m}$), and $S_a = 0.284 \mu\text{m}$ (B) [19].

In the unworn area, the original marks of processing can be observed, but no such marks have been observed on the unworn area. The S_a roughness of the trunnions in the unworn and worn areas showed a statistically significant decrease from 0.558 ± 0.060 to $0.312 \pm 0.028 \mu\text{m}$ ($p < 0.001$) respectively.

Based on the wear data of the hip simulator, the metal trunnions (total wear = 0.29 mm^3) were worn with a quantity similar to that of the bearing surfaces (total wear = 0.25 mm^3). Trunnions wear were also indicated by other experimental data. Trunnion surfaces measured with a 2D contact profile showed a statistically significant ($p < 0.001$) decrease in surface roughness (R_a) after testing (see Fig. 5). In addition, the worn area showed a statistically significant decrease ($p < 0.001$) of the 3D roughness of the surface (S_a) compared to the area of the unworn area (see Fig. 6). This decrease in roughness was due to an original machining mark.

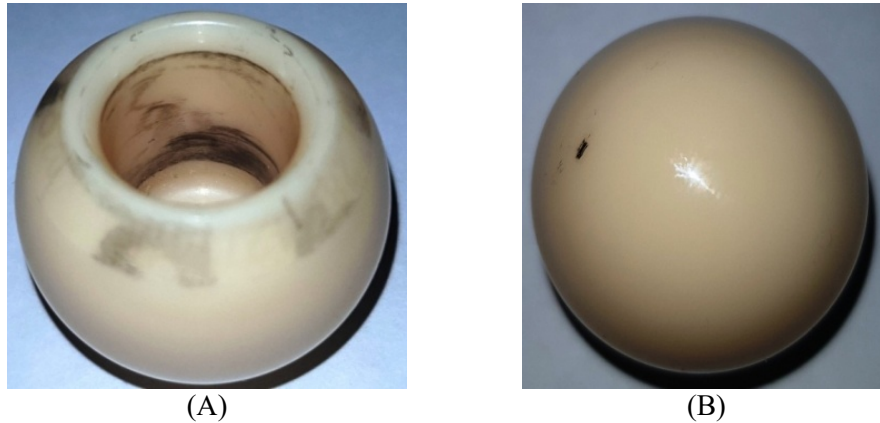
The dark gray traces of the inner taper of the femoral head during this test, as well as the transfer of the material, are shown more clearly in Fig. 7, they illustrate micro-movement and wear through fretting, and a metal wear particle embedded in the outer surface of the ceramic femoral head.

Fig. 7 – A) In internal taper of the femoral head tested at impact on the stem, showing gray marks of micro-movement and wear by fretting, prior to cleaning; B) metallic wear particle embedded in the outer surface of the ceramic head.

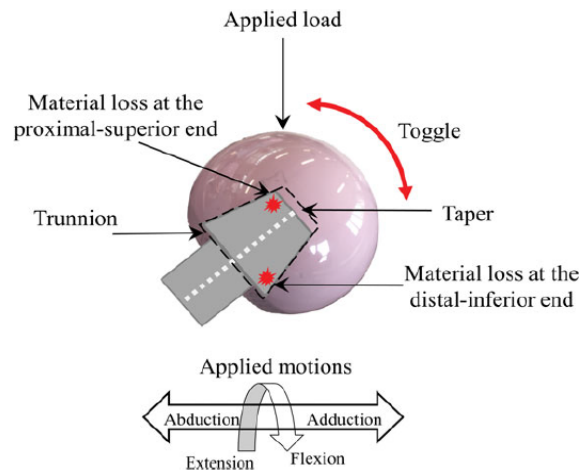
Another study of MoM modular hip recovery also suggested that wear at the taper - trunnion junction was generated by the overturning of the cobalt chromium head (CoCr) on the stem. Because a similar wear pattern was observed in this simulation study, it suggests that "there is a similar change in the position of the ceramic femoral head" as shown in Fig. 8.

Fig. 8 – A ceramic and beaded femoral head test set with applied load and applied movements indicating the overturn and loss of the material in two distinct areas (shown in red) [19].

The uneven loss of the material on the taper junction of the head and trunion may be the cause of femoral head position change, although in this study the wear that was evident on the trunion, probably due to the relative hardness of ceramics compared to titanium. This may also be the result of shocks due to micro-separation, which created the main damage with the formation of wear stripes on the surfaces of the femoral head [31].
