STEM TRUNNION TAPER JUNCTION WEAR WITH FEMORAL HEAD OF A TOTAL MODULAR PROSTHESIS

CONSTANTIN ȚIGĂNEȘTEANU, LIVIU FLORIN ISVORANU, ȘTEFAN ALEXANDRU ILAȘ

Ro. J. Techn. Sci. – Appl. Mechanics, Vol. 66, N° 1, P. 60–78, Bucharest, 2021

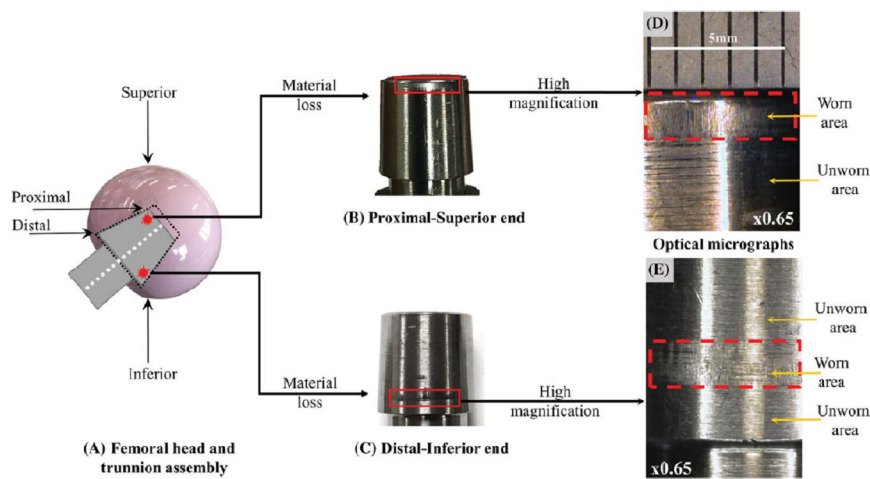
Fig. 2 – (A) a femoral head and femoral assembly showing the different anatomical planes; (B, C) a test trunion indicating wear at the proximal - superior end and at the distal - inferior end, respectively; (D, E) optical microscopic images captured at a 0.65 x magnification showing worn and unworn areas of the superior - proximal end and the distal - inferior ends [19], respectively.

The head and trunion assembly are shown in Fig. 2 (A). On the trunions, the loss of material (as indicated by the reduction of the mass and the decrease of the roughness) was seen opposite the superior - proximal end and the distal - inferior end, respectively, as shown in Fig. 2 (B, C).

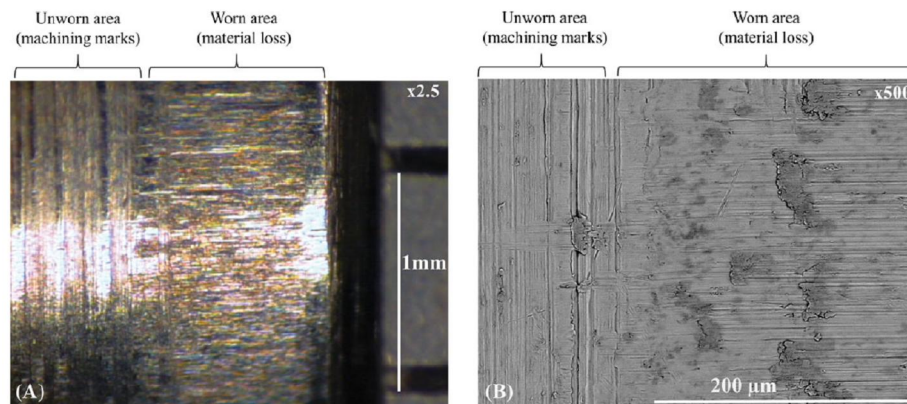
Unworn and worn out areas are clearly visible, and the original circular machining marks are evident in unworn areas. The proximal - superior end of a test trunion can be seen in Fig. 3 (A) at a magnification of 2.5 x, using an optical microscope and at a magnification of 500 x with an SEM of Fig. 3 (B). Again, in the SEM image, two distinct areas, a worn area and an unworn area with original processing marks are displayed.

Fig. 3 – (A) An optical microscopic image at 2.5 × magnification and (B) the microscopic scanning electronics (SEM) image of the 500 × magnification of test trunion, showing worn and unworn areas, [19].

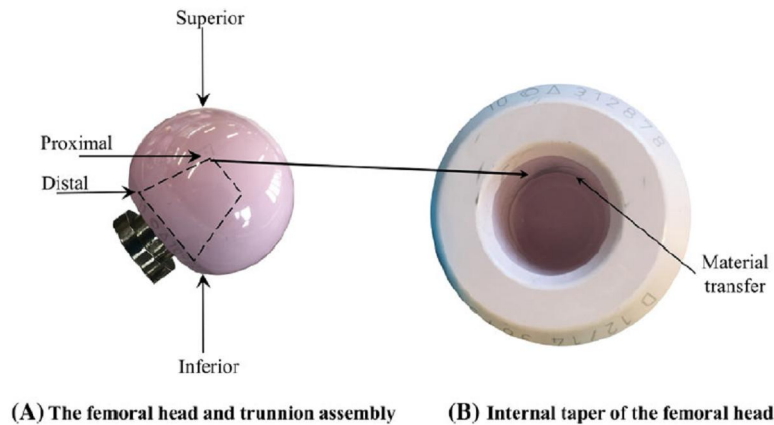
Fig. 4 shows femoral head and a trunion - head assembly, showing the various anatomical planes and internal taper of a tested femoral head showing a gray ring [19].

Fig. 4 – (A) A femoral head and a trunnion - head assembly, showing the various anatomical planes.
(B) Internal taper of a tested femoral head showing a gray ring [19].

Femoral head tapers showed a statistically insignificant change ($p > 0.05$), such as the 2D (S_a) post-test surface roughness, indicating a minimal loss of femoral head material in the form of a gray ring visible at the proximal end of the femoral taper, which probably indicates the adhesive wear transferred from the titanium trunnion to the taper of the ceramics. This is consistent with an explant study, which noted the transfer of metallic material to the taper surface of the CoC and CoP recovery ceramics. The same study, however, did not report any corrosion by fretting or loss of ceramic material, again this being consistent with our experimental results.

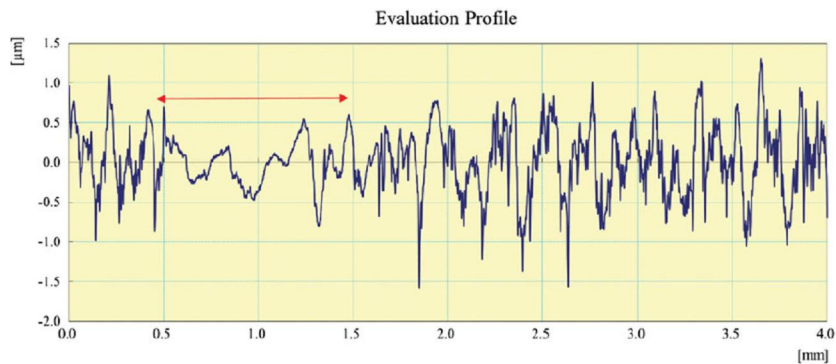
Fig. 5 shows an evaluation of the trace profile of a trace obtained on the distal - inferior end of a test area, which shows the worn area.

Fig. 5 – An evaluation profile obtained at the distal - inferior end of a test trunnion ($S_a = 0.321 \mu\text{m}$).
The red arrow marks the worn area.

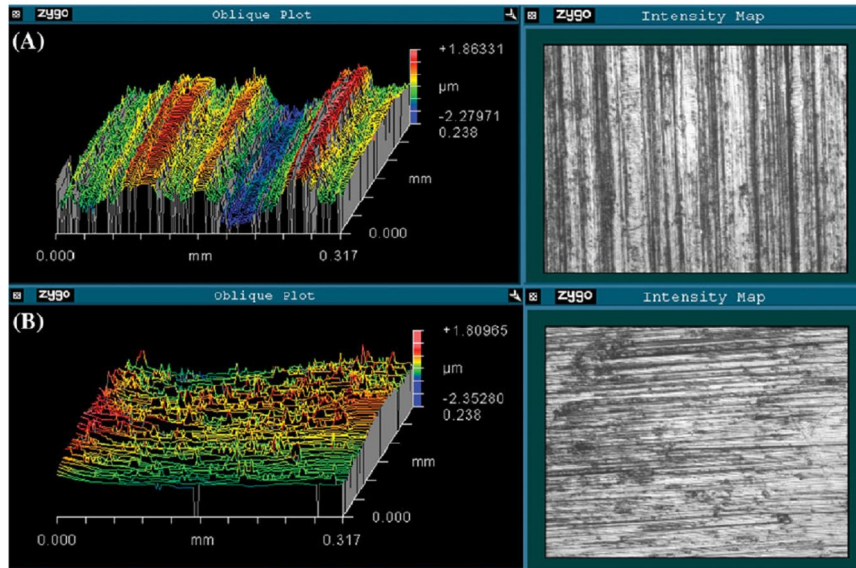
Fig. 6 (A, B) shows profile images acquired with the non-contact profilometer on (A) unworn and (B) worn areas from the superior - proximal end of a tested trunnion.

Fig. 6 – Images of surface topography of a titanium trunion (A) surface with no visible machining marks ($S_a = 0.565 \mu\text{m}$) and (B) ($S_a = 0.284 \mu\text{m}$) [19].

In the unworn area, the original marks of processing can be observed, but no such marks have been observed on the unworn area. The S_a roughness of the trunnions in the unworn and worn areas showed a statistically significant decrease from 0.558 ± 0.060 to $0.312 \pm 0.028 \mu\text{m}$ ($p < 0.001$) respectively.

Based on the wear data of the hip simulator, the metal trunnions (total wear = 0.29 mm^3) were worn with a quantity similar to that of the bearing surfaces (total wear = 0.25 mm^3). Trunnions wear were also indicated by other experimental data. Trunnion surfaces measured with a 2D contact profile showed a statistically significant ($p < 0.001$) decrease in surface roughness (R_a) after testing (see Fig. 5). In addition, the worn area showed a statistically significant decrease ($p < 0.001$) of the 3D roughness of the surface (S_a) compared to the area of the unworn area (see Fig. 6). This decrease in roughness was due to an original machining mark.

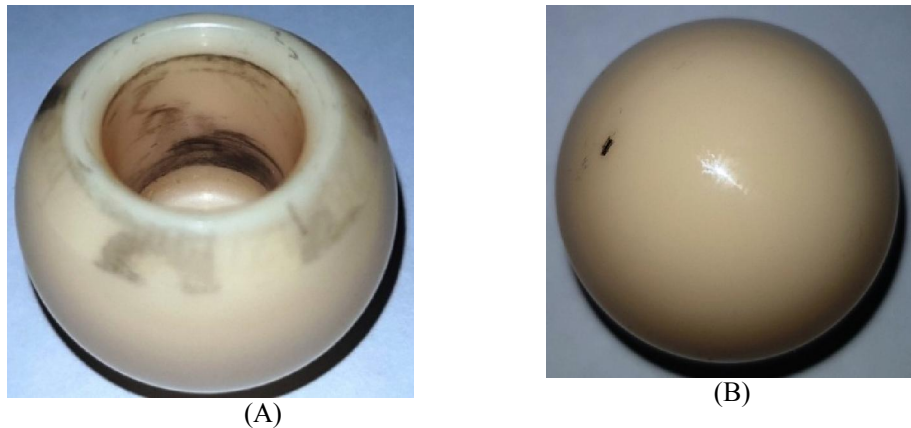
The dark gray traces of the inner taper of the femoral head during this test, as well as the transfer of the material, are shown more clearly in Fig. 7, they illustrate

micro-movement and wear through fretting, and a metal wear particle embedded in the outer surface of the ceramic femoral head.

Fig. 7 – (A) An internal taper of the femoral head tested at impact on the stem, showing gray marks of micro-movement and wear by fretting, prior to cleaning, and (B) a metallic wear particle embedded in the outer surface of the ceramic head.

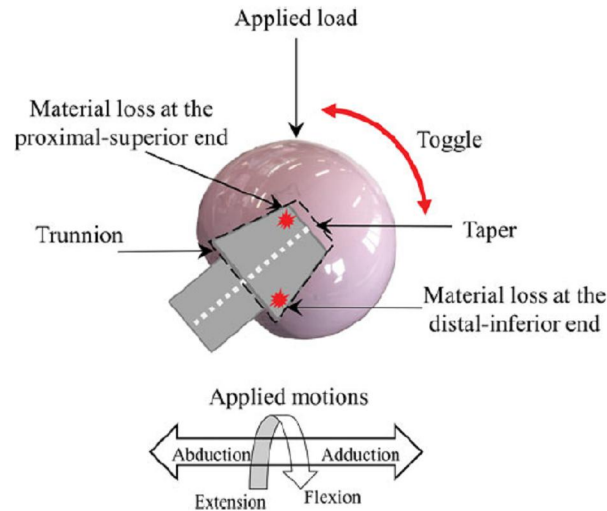
Another study of MoM modular hip recovery also suggested that wear at the taper - trunnion junction was generated by the overturning of the cobalt chromium head (CoCr) on the stem. Because a similar wear pattern was observed in this simulation study, it suggests that "there is a similar change in the position of the ceramic femoral head" as shown in Fig. 8.

Fig. 8 – A ceramic and beaded femoral head test set with applied load and applied movements indicating the overturn and loss of the material in two distinct areas (shown in red) [19].

The uneven loss of the material on the taper junction of the head and trunnion may be the cause of femoral head position change, although in this study the wear that was evident on the trunnion, probably due to the relative hardness of ceramics compared to titanium. This may also be the result of shocks due to micro-separation, which created the main damage with the formation of wear stripes on the surfaces of the femoral head [31].
