RESEARCHES UPON CAVITATION EROSION RESISTANCE OF THE AUSTENITIC STAINLESS STEEL GX5CRNI 19-10 HEAT TREATED

IOAN PĂDUREAN¹, DORIAN NEDELICU²

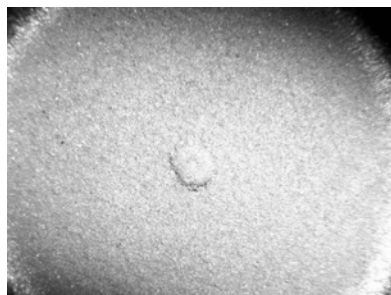
Fig. 5 – The macroscopic structure of the steel GX5CrNi19-10 for different cavitation test duration:
a) 75 min, OM 10×; b) 105 min, OM 10×; c) 165 min, OM 10×; d) 165 min, OM 10×;
e) 165 min, OM 20×.

The macroscopic analyses were realized with a stereomicroscope, at different aggrandizements and the following cavitation eroded area were observed:

- a central zone is heavily eroded and presents crakes and microcrackes;
- a zone adjacent to the central one has only shallow erosions;
- a third zone is also heavily eroded and presents microcrackes;
- a fourth zone has only few erosions.

In some area there has been seen detachments of grains and the occurrence of some porous zones.

Through macroscopic and microscopic analyses it was put into evidence the manner in which the cavitation erosion take place, inclusively the granulation and structural modifications of the layers subjected by cavitation (Figs. 5, 6, 7, 8, 9).

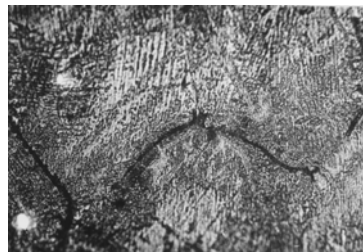
Fig. 7 – Area affected by cavitations with a micro cracks, detachments and grain expulsions – OM 500×.

- In the area unaffected by cavitations, a homogenous austenitic structure with some macles in some grains, with $G = 8$ (Fig. 1).
- In the areas affected by cavitations appear micro cracks on a intergranular layer, detachments and grain expulsions (Figs. 6, 7).
- In the area affected by cavitations appears a grain finish and complex precipitation off and in the austenitic grains (Figs. 8, 9).
- To the gassed nitrating probes appears an iron nitrating and nitrates of the adding elements with a thickness untill 0.10 mm.
- Between the nitrating layer and the submissive nitrating material appears a transition layer with nitrates and nitrating precipitations in crystalline grains.

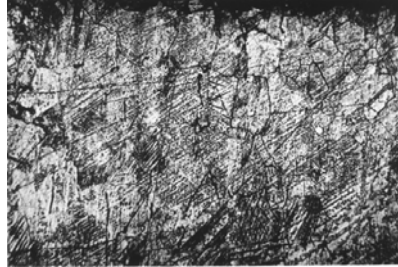
Fig. 8 – Area affected by cavitations with a grain finish and complex precipitation – OM 500×.
