# **INFLUENCE OF STRUCTURAL STATE UPON THE CAVITATION EROSION OF GX5CrNi19-10 AUSTENITIC STAINLESS STEEL SUBJECTED TO SOLUTION TREATMENT**

The paper continues the previous researches of the authors, on the same topic-cavitation erosion- researches which ended with a Ph.D. thesis and through other works. Samples of the austenitic stainless steel GX5CrNi19-10 have been heat treated and tested under cavitation erosion. There have been obtained modifications of the cavitation resistance according to the thermal treatment. By use of structural analyses and micro hardness tests, the influence of microstructure on the steel cavitation resistance was emphasized. The thermal treatment of solution treatment increases cavitation erosion resistance to GX5CrNi19-10 austenitic stainless steel.

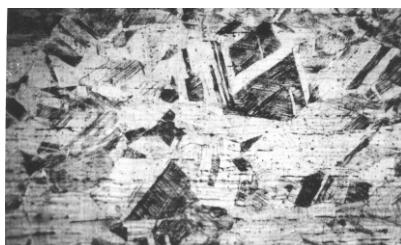
Fig. 2 – A zone OM 100×.

- *for the area unaffected by cavitations:*
  - a homogenous austenitic,
  - structure with macles in some grains, with  $G = 8$  [12],
  - this structure is corresponding to the solution treatment applied to the austenitic stainless steel;
- *for the areas affected by cavitations appear structure changes:*
  - in the areas affected by cavitations appear microcracks on a intergranular layer, detachments and grain expulsions (Figs. 3, 4),
  - crystalline refinement and carbides precipitation (Fig. 5).

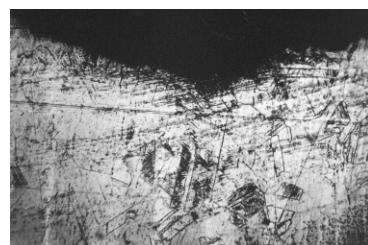
Fig. 3 – B zone OM 100×.
